**National Highway
Traffic Safety
Administration**

Case Vehicle (A): 1999 Ford
Type: Escort ZX2, 2-door coupe
Driver: 18-year-old male
CDC: 02-RZAW-3

Veh. (B): 1999 Dodge
Type: Ram 2500 Laramie SLT 4 x 4,
Quad cab pickup with trailer
Driver: 40-year-old male
CDC: 12-FDEW-1

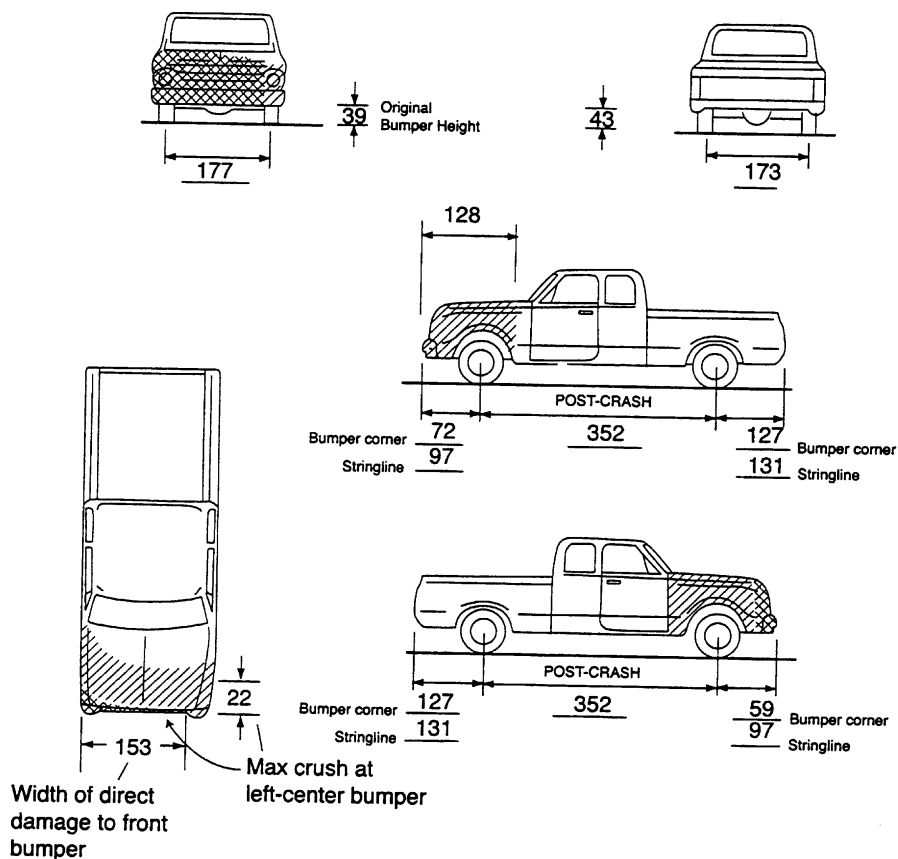
(Slide 7) Damage to vehicle (B) was minor. (Slide 8) The maximum crush was 22 cm at the left center of the front bumper. Direct damage began at the right bumper corner and extended 153 cm to the left. (Slides 9 and 10) There was no change in either wheelbase.

Direct Damage Length (DDL) 153 cm

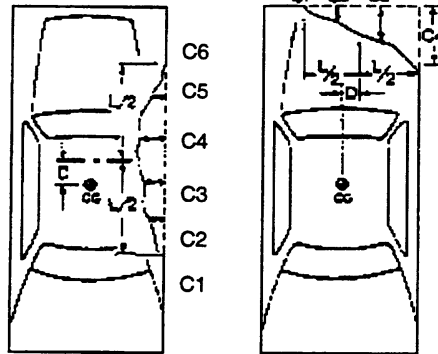
Specific Impact No.	Location of Direct Damage	Location of Field L
1	Begin R+H BC 153 cm to left	Ft Bumper BC to BC

DL 153
UDL 27

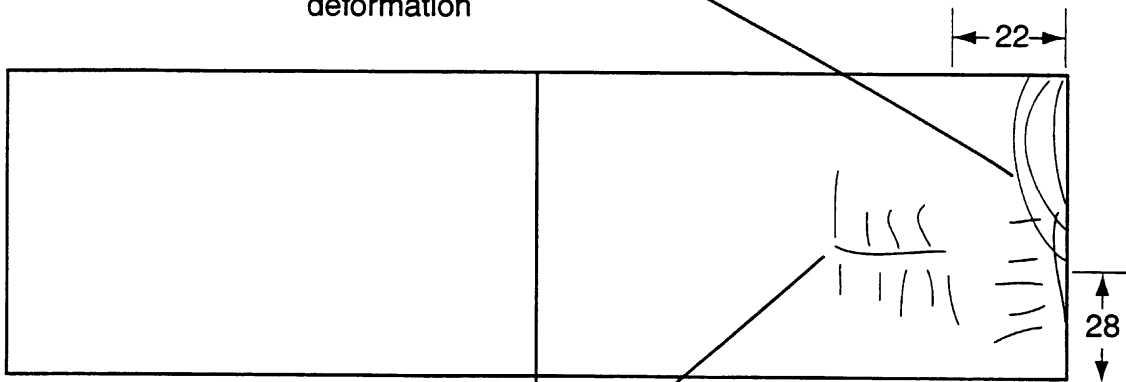
Cracked due to upper A-pillar
deformation

In the front, (slide 26) the right portion of the windshield was cracked due to contact by the passenger airbag cover and upper A-pillar deformation. (Slide 27) There was no other damage to the front of the vehicle.

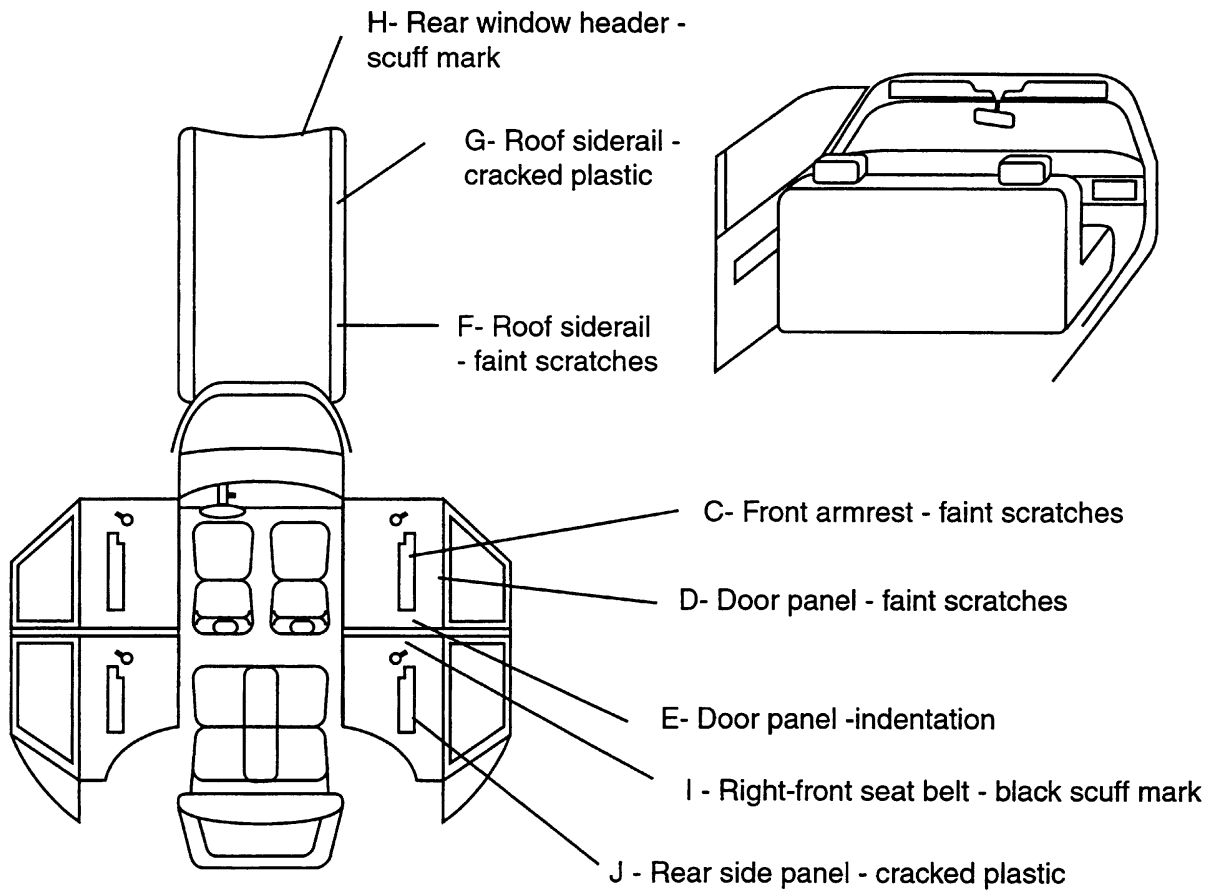
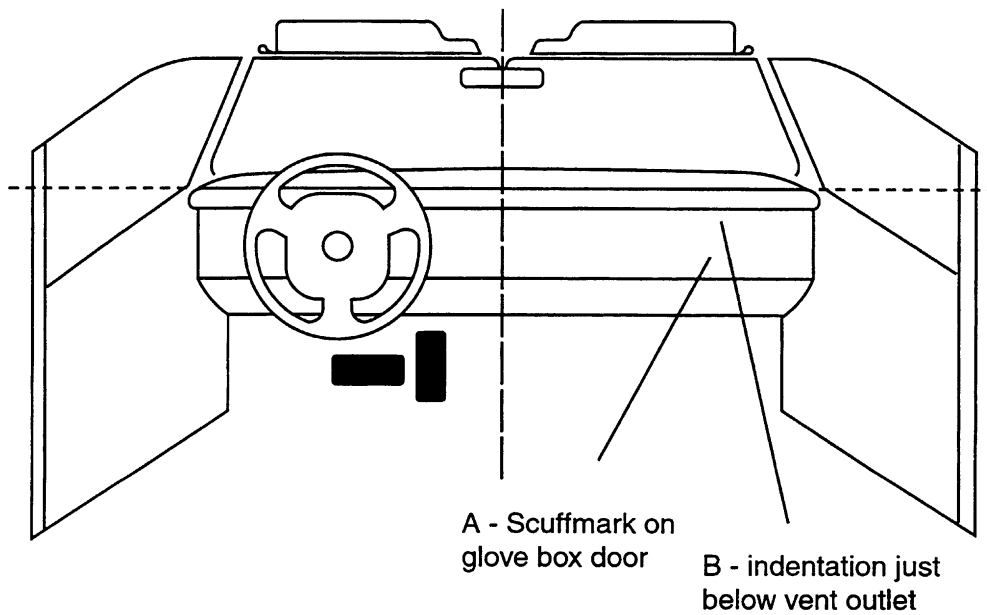
VEHICLE OCCUPANT CONTACT DIAGRAM

Contact	Interior Component Contacted	Occupant No. if Known	Body Region if Known	Supporting Physical Evidence	Confidence Level of Contact Point
A	Glove box	Right front	Leg	Scuff mark	2
B	IP above glove box	Right front	Leg	Indentation	2
C	Lt. front armrest	Right front	Right side	Faint scratches	2
D	Lt. door panel	Right front	Right side	Faint scratches	2
E	Lt. door panel	Right front	Right side	Indentation	1
F	Roof siderail	Right front	Head	Faint scratches	2
G	Roof siderail	Right rear	Head	Cracked plastic	1
H	Rear Window header	Right and Left rear	Heads	Scuff mark	1
I	Right front seatbelt	Right rear	Right leg	Scuff mark or skin transfer	1
J	Rear side panel	Right rear	Right side	Cracked plastic

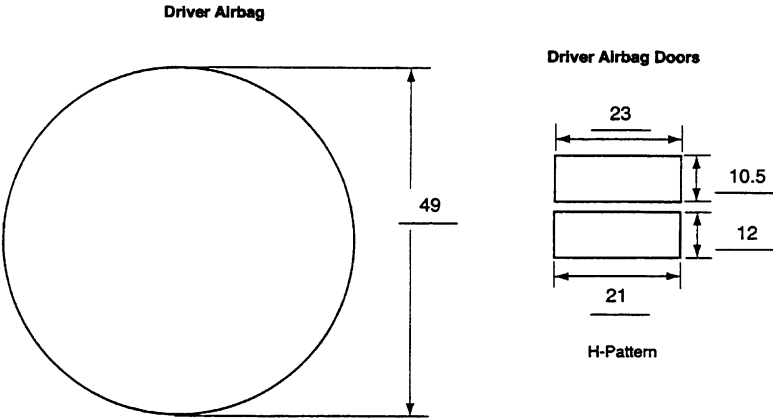
AIRBAG NUMBER ON DRIVER SIDE:

Vents: ☒ Y N
if yes, how many: 2
at 11 and 1 O'clock

Tethers: ☒ Y N
if yes, how many: 2

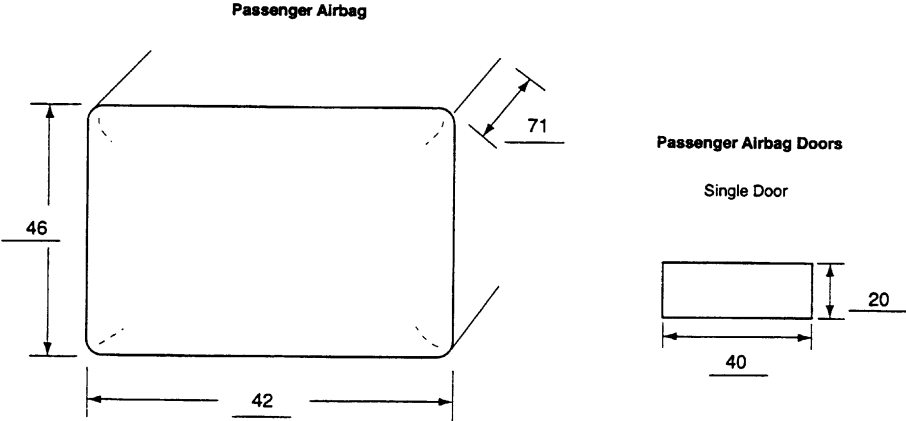
AIRBAG NUMBER ON PASSENGER SIDE:

Vents: ☒ Y N
if yes, how many: _____

Tethers: Y ☒ N
if yes, how many: _____

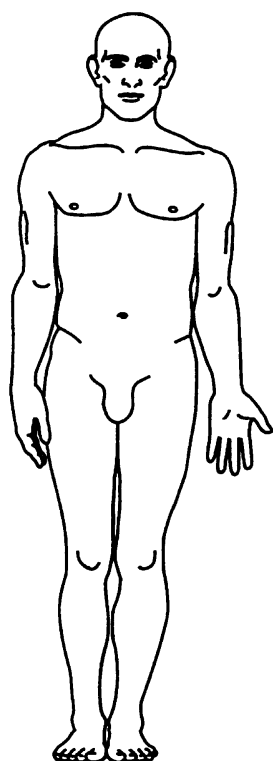
INDICATE LOCATION OF INJURIES.

Laceration, posterior
aspect of scalp
(1)
